Rehabilitation of Grimes Creek, a Stream Impacted in the Past by Bucket-lined Dredge Gold Mining, Boise River Drainage, July 2008 to August 2011.

Pam Harrington
TU,1020 W. Main Street Suite 440, Boise, Idaho 83702

Robert House
BioHouse LLC, 1453 N. Ellington Pl., Eagle, Idaho 83616

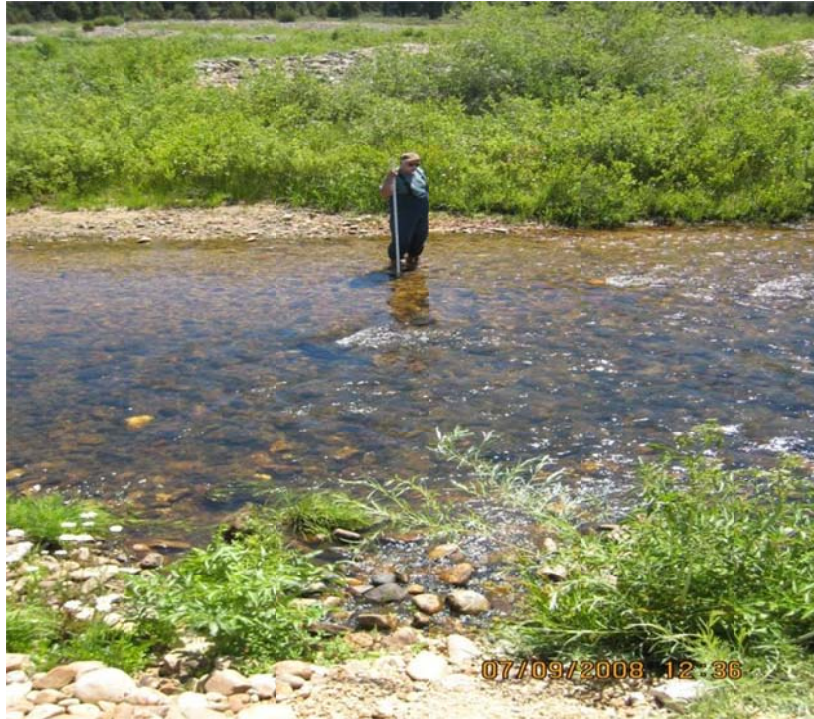
The project stream section had an extremely altered floodplain from past gold dredge mining. The riparian community along the project stream section was a willow dominated understory with a limited black cottonwood overstory. The channel ranged from 0 to 2% in stream gradient, had some sinuosity, relatively wide width/depth ratios in riffles and glides and mostly stable streambanks (Photograph 1).

Photograph 1. A typical riffle unit of Grimes Creek in the study area.

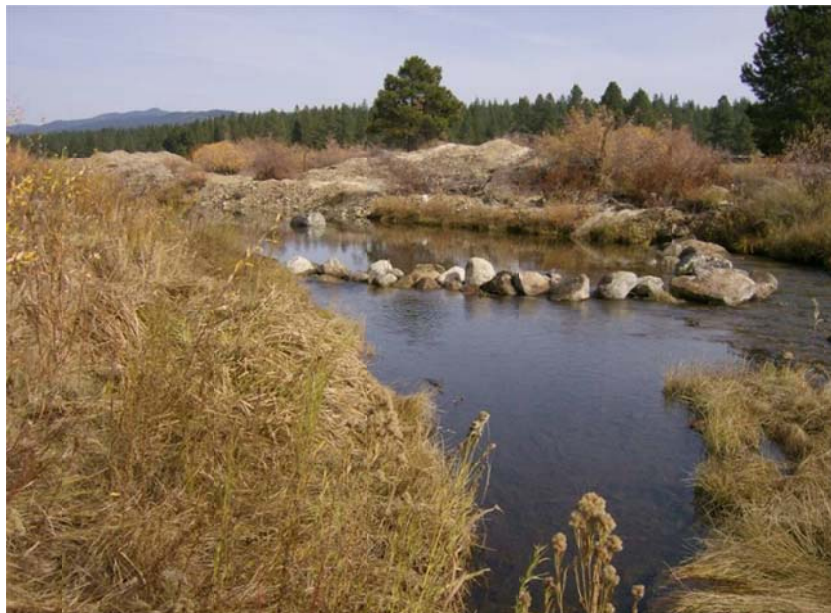
Photograph 2. Initial construction of a downstream facing “V” designed to direct water down a side channel on the right bank.

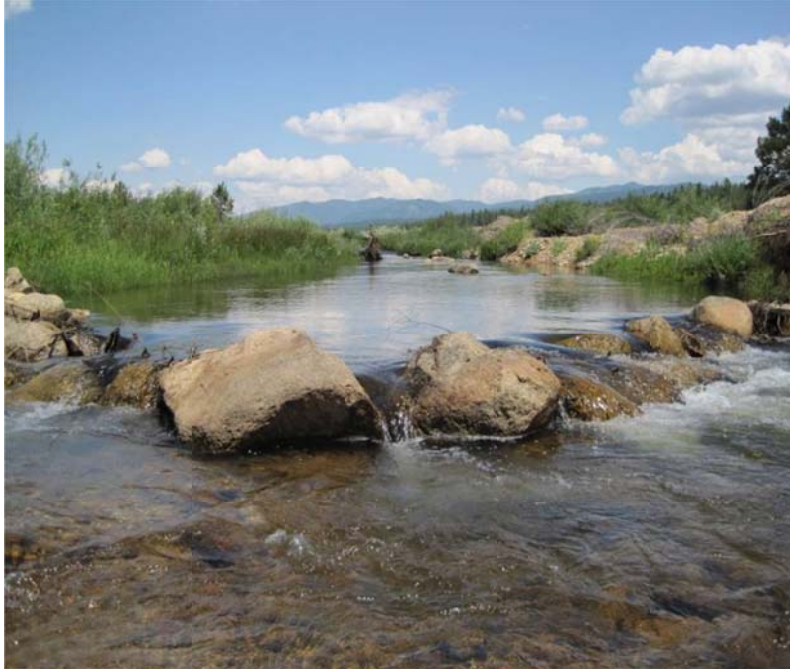
Photograph 3. The same downstream facing “V” in Photograph 2 after one year of spring high flows, showing a long upstream dam pool.

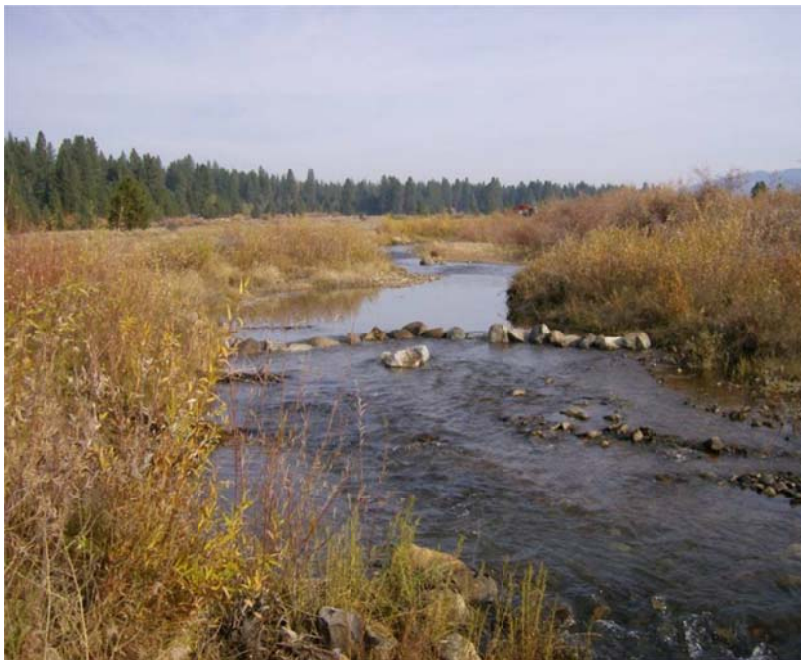
Photograph 4. A typical upstream facing “V” structure right after installation

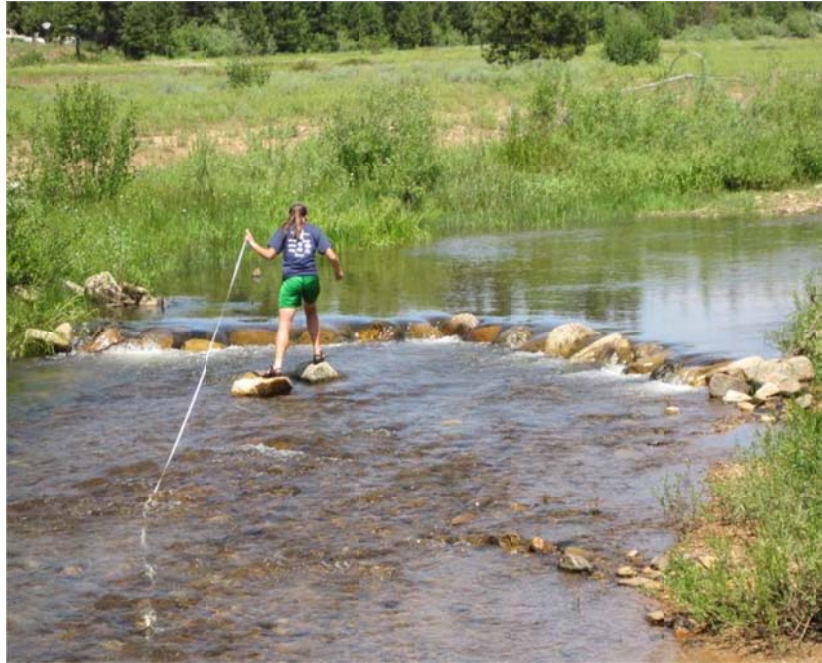
Photograph 5. A upstream facing “V” structure after one year of spring high flows.

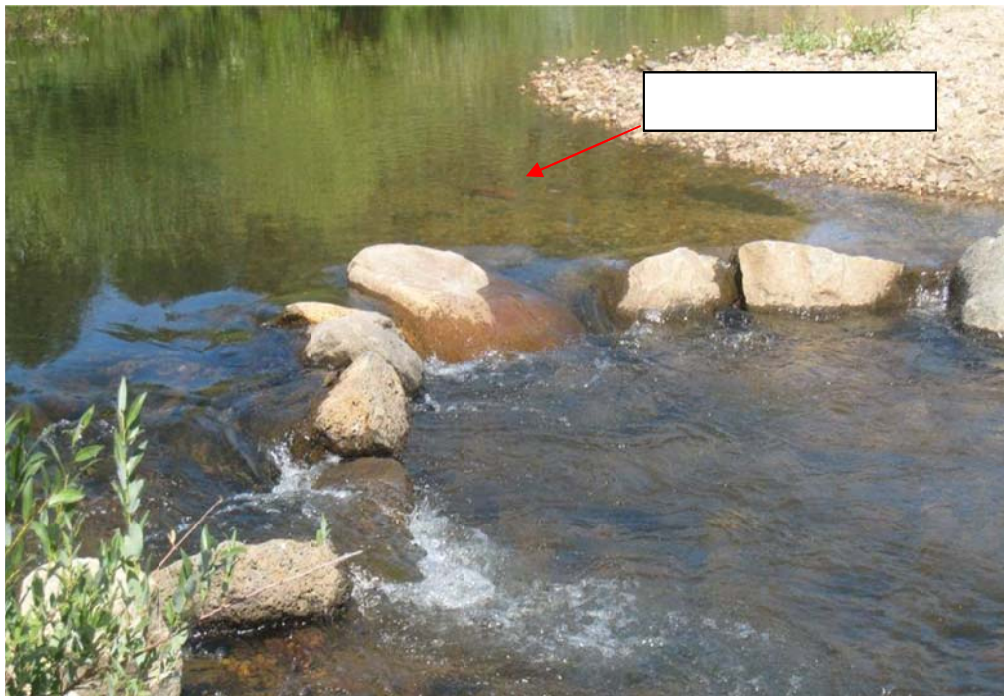
Photograph 6. An upstream facing “V” structure showing a kokanee spawning just upstream from the structure.
